March 1988
Vol. 51, No. 4

Public Roads

**Pedestrian Safety
for Older Adults**

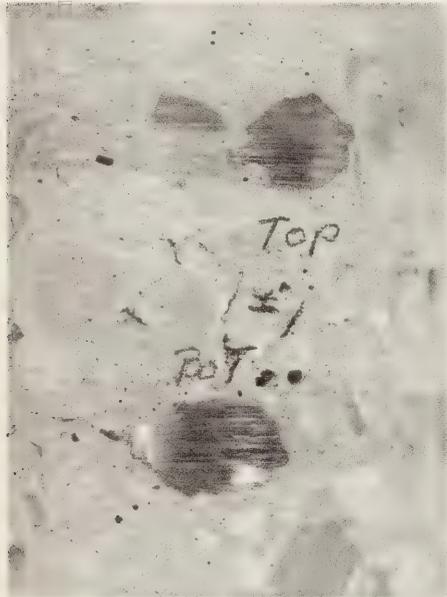
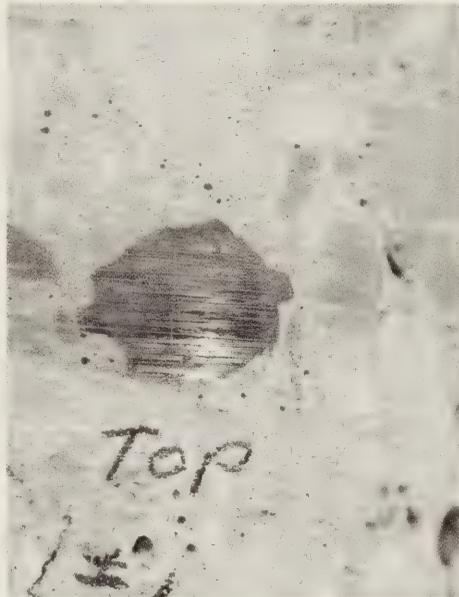
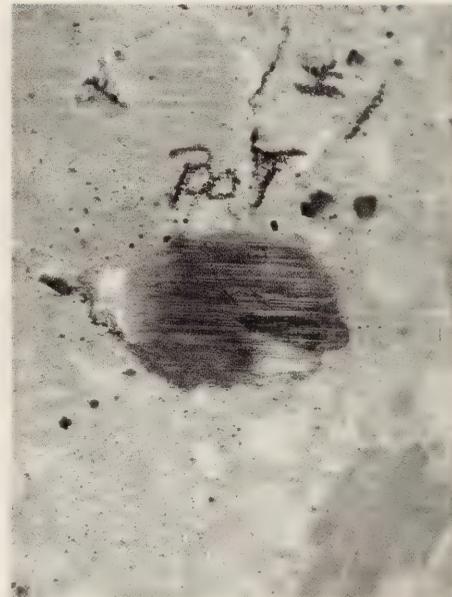
Core 1. Top and bottom mat rebar steel.

Core 1. Top-mat steel.

Core 1. Bottom-mat steel.

Figure 1.—Concrete Core No. 1 with reinforcement.

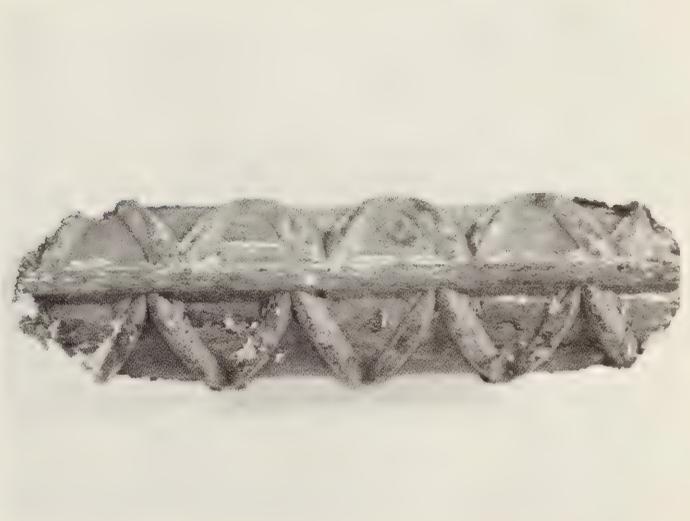
Core 3. Split open, top-mat steel rebar.

Core 3. Split open, bottom-mat steel rebar.

Figure 3.—Top and bottom mat steel rebar in Concrete Core No. 3.

The extracted core was split open by researchers and the rebars removed; concrete paste hardness was then tested on the imprinted rebar surface (fig. 3). Testing indicated no significant difference between the paste around the rebar imprint surfaces and the rest of the core. The concrete broke through quartz aggregate; this indicates that the bond between the paste and aggregate is good. While concrete residue was strongly adhered to the top rebar, none was found on the bottom rebar. The steel was clean and virtually free of rust stains on both the top and bottom rebars.

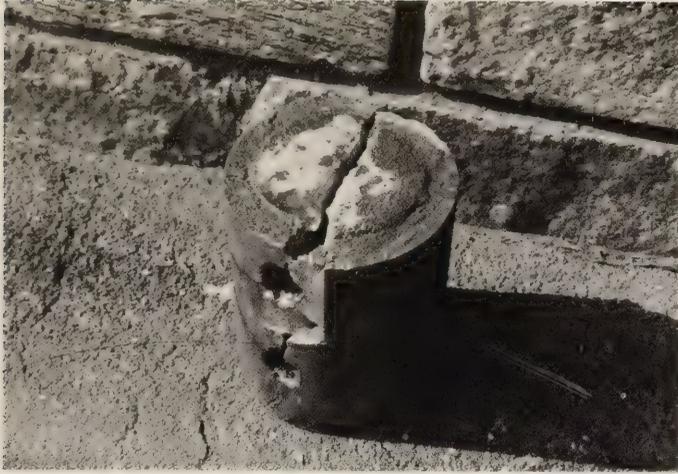
Concrete core after rebar is pulled out.

Embedded rebars in fractured core.

Figure 5.—Core No. 2 after pull-out test.
